National Register of Historic Places Registration Form

Historic name: William Sever House

Street & number: 2 Linden Street

City or town: Kingston State: Massachusetts County: Plymouth

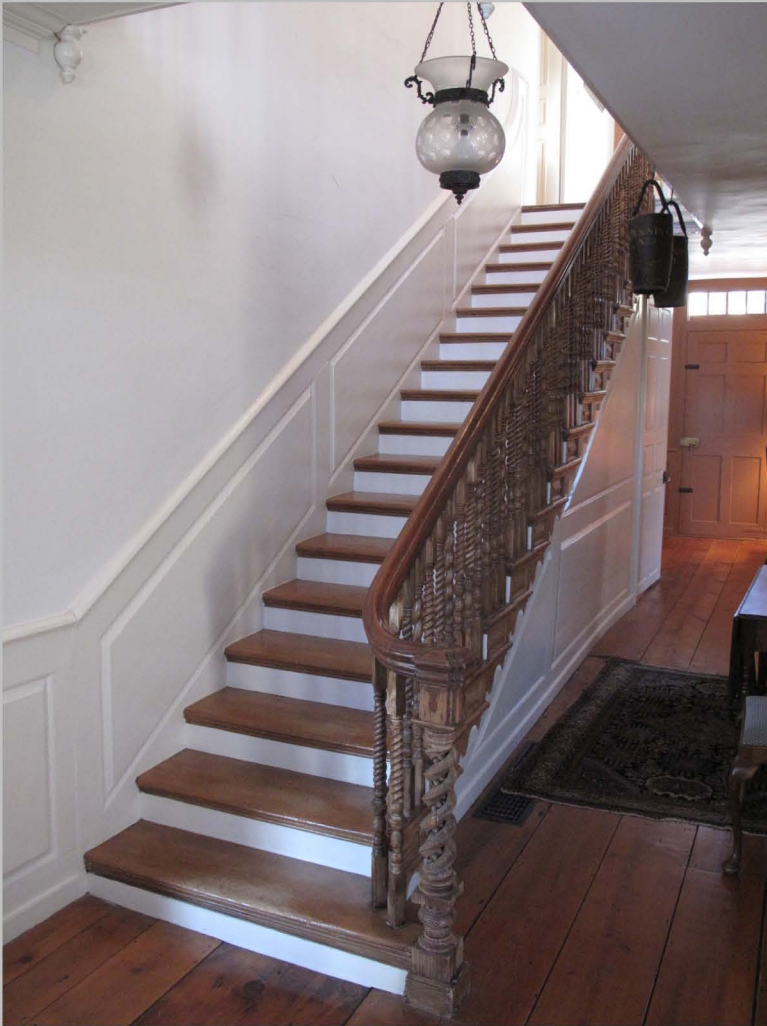
7. First floor center hall & stair looking north.

Center Hall. In the manner of elite house models, the Sever House has a symmetrical plan with four rooms on a floor, two on each side of a center hall (FIGS.4&7). It was during this time that in better houses the center chimney was replaced with two chimneys positioned between the rooms on each side of the center passage, which traversed the space formerly occupied by the center chimney. In smaller houses with plans only one room deep, chimneys were positioned on rear or end walls. The scale and symmetry of the plan was critical to the design of large houses and the lifestyles they supported. There was a hierarchy of spaces that was reflected in the levels of decoration. The center passage was the entry point for visitors and presented an immediate statement of the owner's status. In the Sever House the entrance opens on a wide hallway with a paneled wainscot and wood cornice. Closets with paneled doors encase the inside of the entrance, and doorways into the front rooms have complex architraves. But, the centerpiece of the space is the long, elegant staircase rising up the west wall to the second floor in one straight run with the hall side enclosed with a paneled wall (PHOTO 7). The notable decorative feature is the hand rail supported by three different kinds of twist-turned balusters in series, three on each step, originating at a newel post with its twisting post hollow-carved.

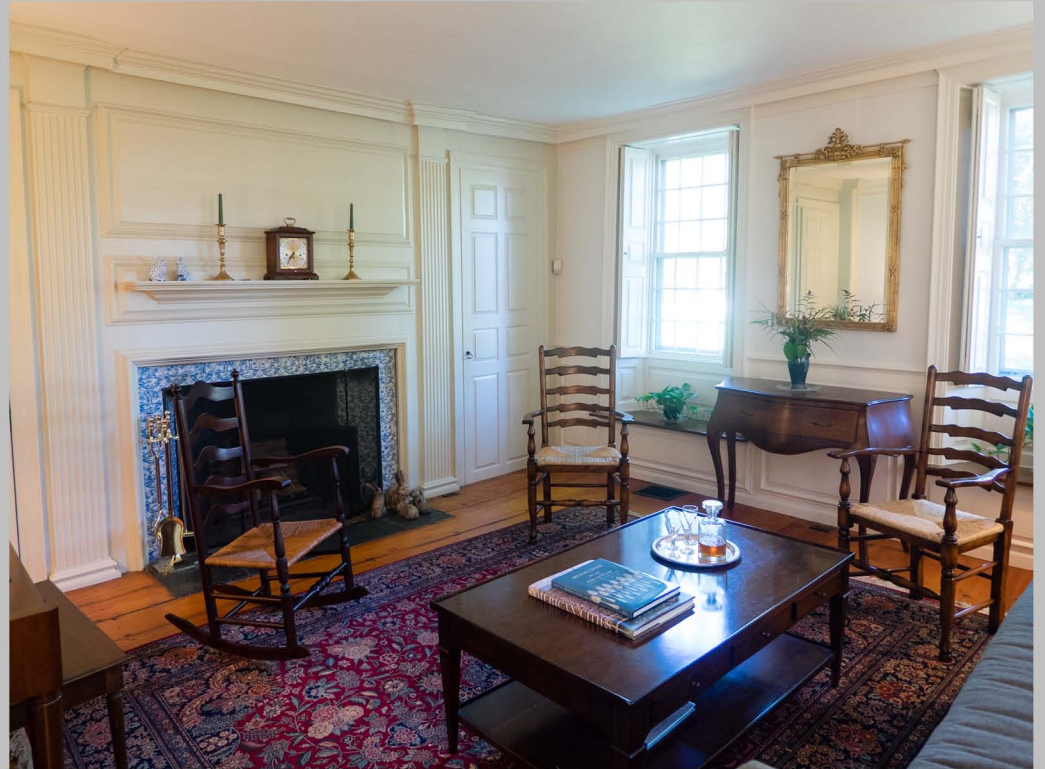
8. First floor parlor looking northeast.

Parlor. Meant to be an imposing space, the best room is located on the east side of the center hall (FIGS.4&8, PHOTO 8). It is larger than the front room on the west side of the hall and has a higher level of finish. The exterior plank walls of both rooms are studded out on the interior to create sufficient depth for window seats and jambs for recessed folding shutters. A wide fireplace is centered on the north wall beneath a chimneybreast composed of two wide panels: a narrow one above the fireplace and one much wider across the top. Both are proud of the wall and surrounded by bolection moldings. This is a paneling pattern and technique repeated throughout the house. The mantel shelf and bolection surrounding the firebox were added in the 1950s when a Federal-period mantelpiece, itself an addition, pictured in the 1935 HABS documentation, was removed. The chimneybreast is flanked by fluted pilasters that extend from the floor to the ceiling where a wood cornice wraps around them creating a capital. On the outside of the pilasters are tall narrow doors with eight panels, alternating tall and short like the paneling, opening on closets in the chimney space; the one on the east side was permanently affixed when a lavatory was created in the space behind.

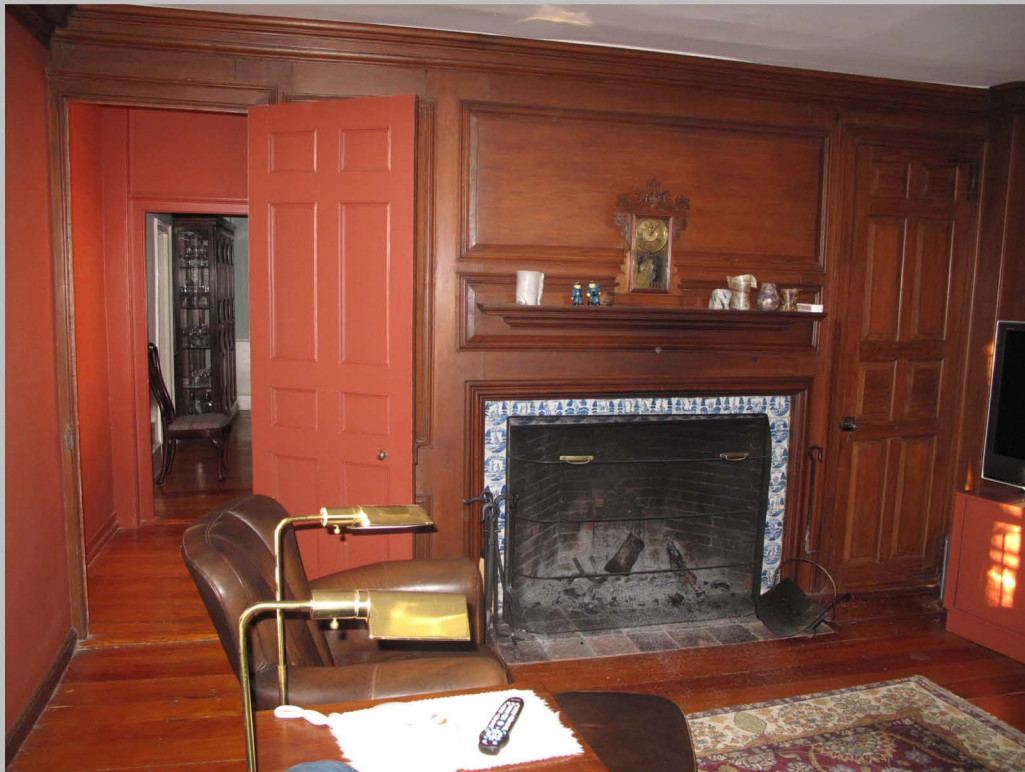
9. First floor living room looking northeast.

Living Room. Next in the hierarchy of spaces is the room on the west side of the hall (FIG.4, PHOTO 9). It is a smaller room as the chimney on this side of the house was shifted forward to create more space in the room behind it, which originated as the kitchen. (In this plan the front room possibly functioned as a dining room.) The fireplace is off center on the north wall because the chimney also included a bake oven on the kitchen side. This section of the chimney is concealed behind an extra section of paneling, vertically configured, on the west side of the hearth. This paneling, as well as the chimneybreast, was fabricated in a manner identical to that in the parlor, and eight-panel doors are positioned at the corners, one on the east opening on a closet and one on the west on a passageway leading to the kitchen, although a second set of stairs may have occupied this space. Like the parlor, the current fireplace is faced with blue-and-white tin-glazed earthenware tiles in an iron frame and bolection trim and a mantel shelf added in the 1950s when a Federal-style mantelpiece was removed. A wood cornice surrounds the room at ceiling level but there is no wainscot. Two windows on the south wall and one on the west wall are recessed with window seats and folding shutters contained within the jambs. The natural wood finish of the paneling and other woodwork is a ca. 1960 alteration; a documentary photograph taken in 1935 depicts the woodwork grain-painted. The trim on the doorway leading into the center hall is 19th-century in design.

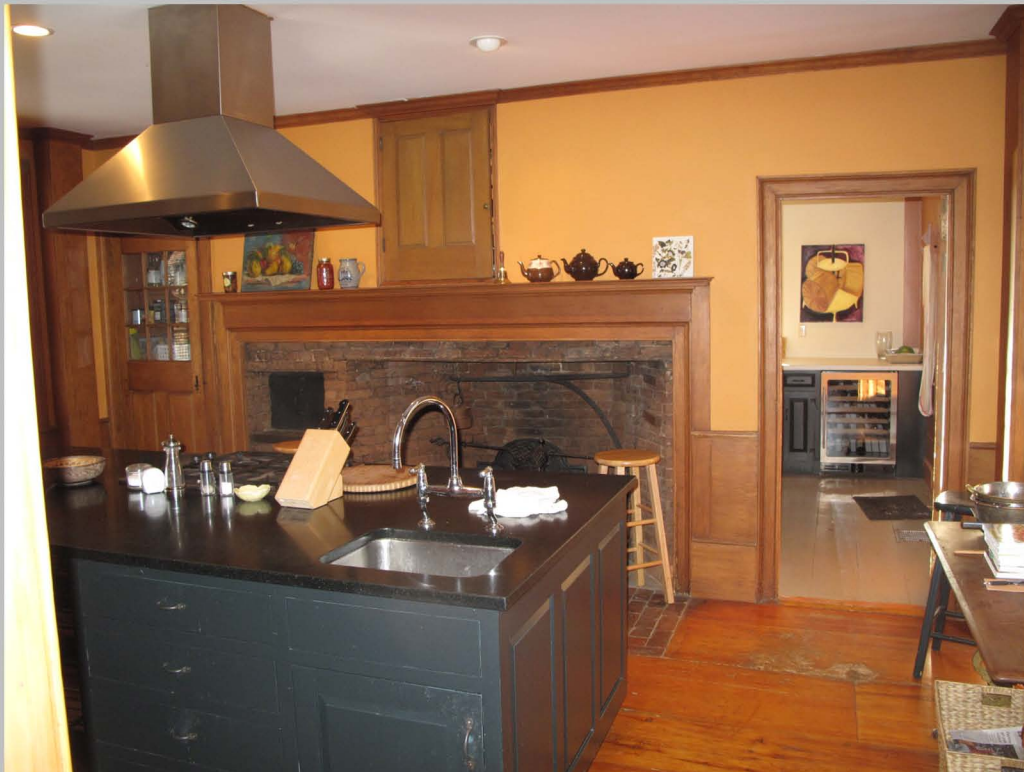
11. First floor kitchen looking west.

Based on an assessment of materials and design features, it is evident that the existing kitchen was created in the early 19th century and probably updated in the 1840s (FIG.4, PHOTO 11). Kitchen technology changed frequently in this period, as cooking hearths were replaced with stoves, and wealthy families like the Severs would have kept pace with the improvements. The fundamental plan as documented in 1935 with a kitchen, pantry, service hall connecting to the dining room in the house and outside, and a laundry behind the chimney is intact and represents a well-developed service wing associated with the best houses of the period. A second floor, removed in the 1950s, was documented by HABS as having four unheated bed chambers and a heated common room. Since 1935, stairs have been removed from the service hall (no longer needed once the second story was removed) and the dividing partition with the pantry removed to create a single pantry/hall space with cabinetry added to the long walls. A window once on the east wall of the pantry has been converted to a door, which leads to a sun porch added to the rear of the house in the 1950s. A window appears on the north wall of the pantry on the HABS floorplan; it has been removed. Extant door and window trim relate to the early 19th-century construction date. The kitchen space has two windows on the south wall, corresponding with the front façade, and one centered on the rear wall, which also have Federal-style surrounds. The masonry, woodwork and hardware used in the construction of the cooking hearth and oven associate the features with early 19th-century materials and methods. The mantelpiece and closet door above it have trim with Federal-period profiles. A wainscot of wide pine boards encircles the room; all woodwork in the space has been stripped of its paint. The functionality of the kitchen has been brought up to current standards with the recent addition of a large island containing a sink and appliances. The back of the fireplace, oven and chimney are exposed in the room behind the kitchen, that appears to have originated as a laundry space. A doorway on the north wall leads to the exterior, and there are windows on the other three exterior walls. Cabinetry and kitchen appliances have been added to the west wall and a refrigerator occupies a space that the 1935 HABS floorplan indicate was once the location of a “brick set boiler.”

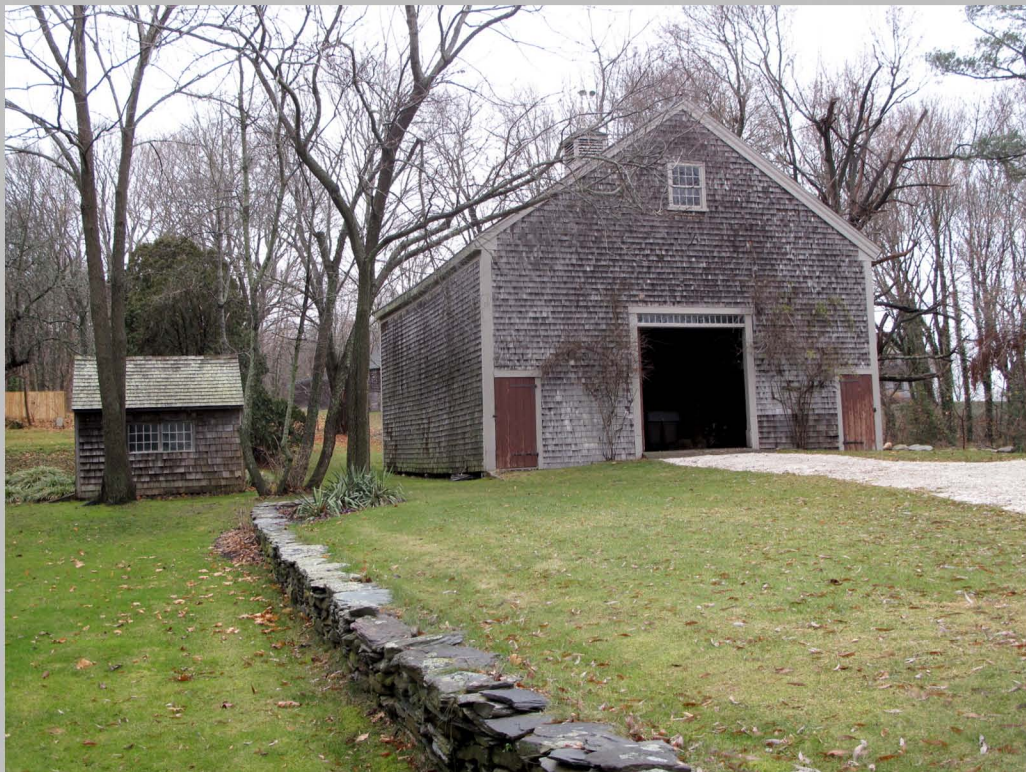
14. Barn exterior from southwest, garden shed on left.

A wood-shingled barn is located east of the house on the property line (FIGS.3&6, PHOTOS 2&14-15). It is accessed by its own driveway leading from the street and is elevated on a low terrace with a stone retaining wall. Its framing materials and methods are similar to the Carriage House but the barn's outward design suggests it was built somewhat later, closer to the mid-19th century. Its gable roof is oriented to the street with a façade containing a large wagon door with a multi-pane transom in the center and smaller doors in each corner. A window is centered high in the gable and a ventilator is positioned on the ridgeline. Side walls contain no fenestration and a pair of smaller doors and a window are centered on the rear (north) end. The interior of the barn has an aisle plan with a wide center aisle framed by tall posts running front to rear flanked by smaller side aisles under the eaves (PHOTO 16). Elevated platforms erected above the aisles provided for hay storage in the upper reaches of the building and roof while different functions associated with stabling and care of domestic animals occurred at floor level. Other than having the floor area cleared of stalls, mangers, bins and other evidence of animal husbandry, the

A building is depicted in this location on the site plan drawn for HABS in 1935 and identified as a “summer house,” and although the footprints are similar, the existing garden shed bears little resemblance in design and materials to such a building (FIG.3, PHOTO 14). It is a non-historic building.

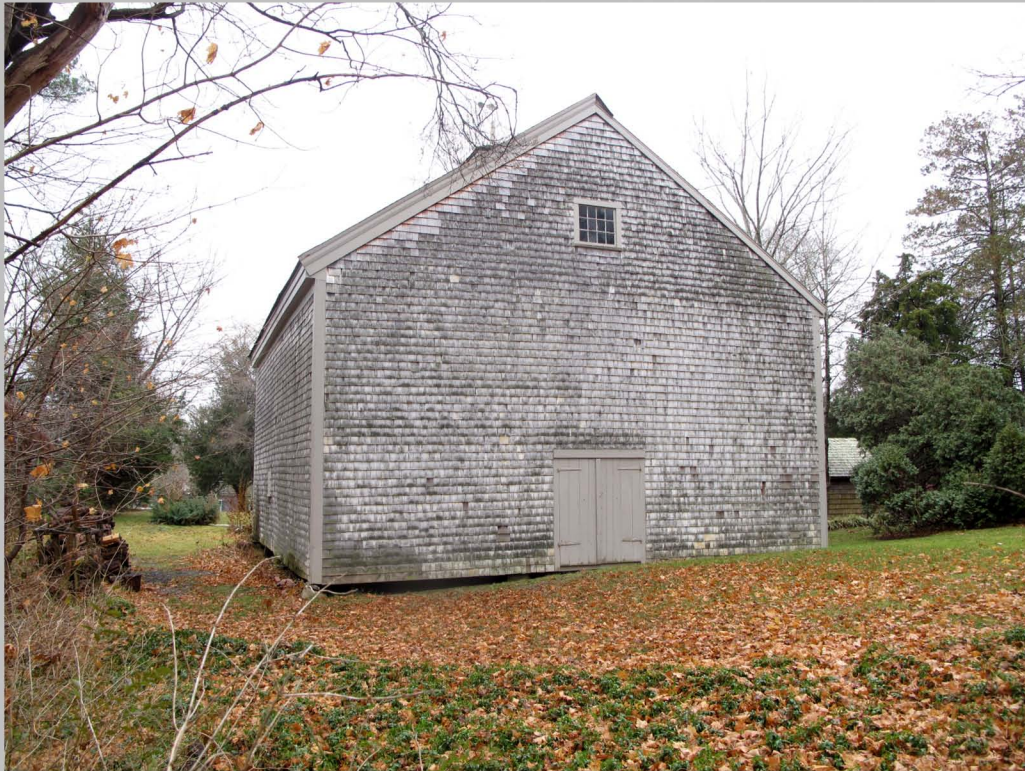
15. Barn exterior from northeast.

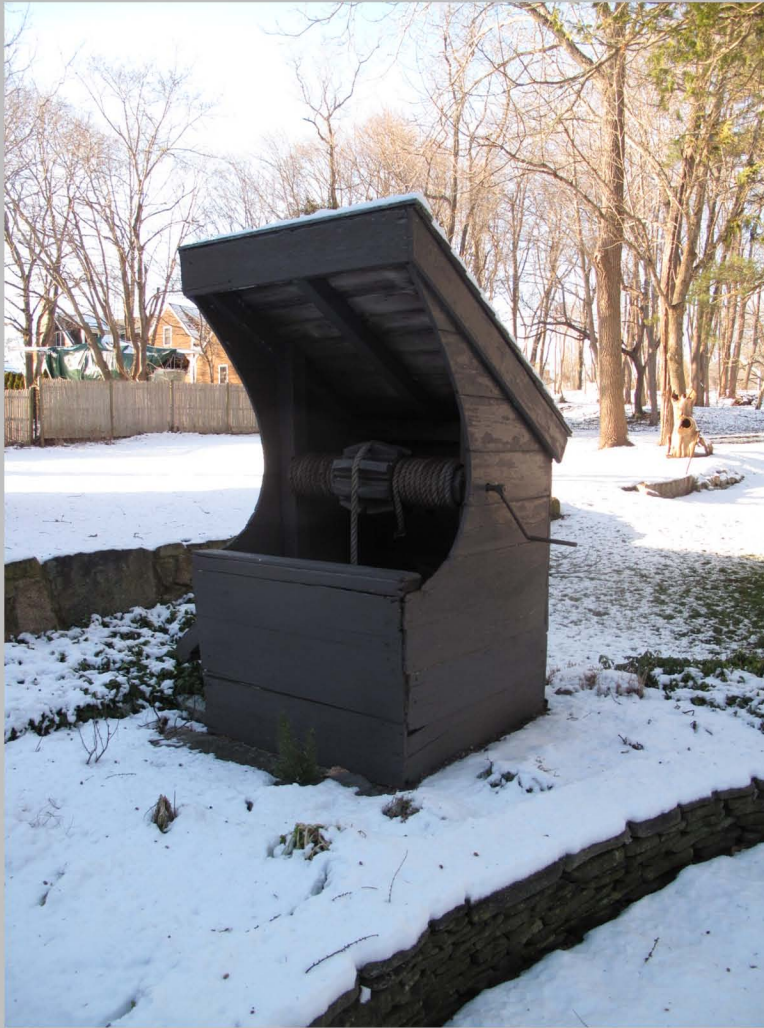
17. Well house from southeast.

A well is located just behind the kitchen wing (FIGS.3&11, PHOTO 17). It is contained in a wood housing that has a steep-pitched shed roof sheltering the well and its drawing mechanism. Sheathed in horizontal plank siding, the side walls are notched out back to the crankshaft. The sweeping curve of the opening begins at the roof and descends to a low front wall over which a pail can be retrieved and dumped into a trough protruding through the west side of the enclosure. Well-documented by the HABS team in 1935, the structure and its mechanism appear to date to the 19th-century; however, its exact construction history is not known. The well, itself, probably was dug at the time the house was built.
