# FIRST PERIOD SURVEY

FORM B - BUILDING

•	Town Danvers ·	
30-36A	main view	Address 273 Maple St.	
0-36	Summer tie beam, left hand room	Historic Name Prince Osborne House	
0-26	staircase detail, first floor	Use: Present Residential	
30-22	staircase, first floor	Original Residential	
30-21	right-hand room, rear wall	DESCRIPTION  Date ca. 1700, 1715	
30-23	left hand room	Scurce Stylistic Analysis	
30-32	detail, panelling, rear wall, righthand room	Style First Period	
30-30 Sketch I	transverse summer beam and post of front wal	1Architect Unknown  Exterior Wall Fabric Clapboards	
BAY BERZY	Gours See	Outbuildings None  Major Alterations (with dates) Ell removed.  leantos added, early 20th c.  Condition Good	
<i>[ E</i>	ROAD (INEYAR) 5-	Moved Yes Date 1915  Acreage less than one acre  Setting Suburban residential street of widely spaced houses of mixed date.	
UTM REF	Z E N ERENCE 19 / 339-610 / 4715-120	Recorded byAnne Grady	
	ADRANGLESalem	Organization Boston University

Community:	*	Form No:
DANVERS		79
Property Name:	Prince-Osborn House

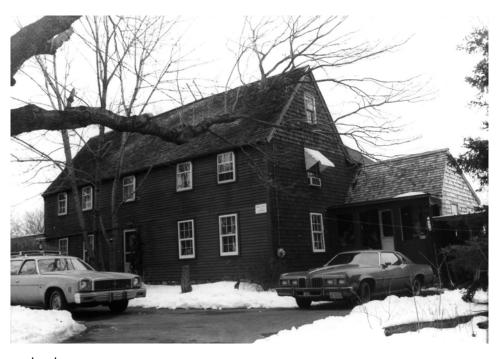
main view

The Prince-Osborne House is a two and one half story building with steeply pitched roof. The main body of the structure, five bays wide and one room deep, incorporates two distinct First Period frames which together make a symmetrical plan. Atypically, the chimney bay appears to be part of the later, right hand frame. There are additions to the sides and rear: mid 19th century ell to the right rear, a mid 20th century car shed to the left, a lean-to to the left rear, and a small wing to the right. whole is enveloped in simple finishes with clapboards on the facade and shingles elsewhere. Fenestration, evenly spaced on the facade, is of simply framed sash windows throughout. The central doorway is unornamented. A small hewn overhang extends across the facade to the left of the doorway, indicating the location of the earlier frame within. two chimneys which pierce the rear roof slope are 1915 reproductions of earlier chimneys removed before the house was relocated from its earlier site on Summer Street in Danvers. The location of those chimneys represents a reorientation probably in the late 18th century of the fireplaces in the principal rooms from inner wall served by central chimney to rear wall.

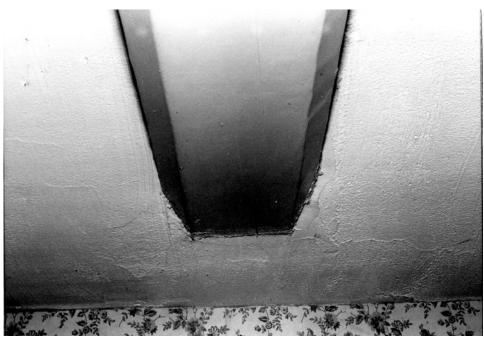
Summer tie beam, left-hand room

In the left hand room, believed to be the earlier side, the longitudnal summer beam is 12 inches wide and has 1 1/2 inch flat chamfers and triangular curved stops. The chimney post is finished with a flat chamfer and taper stop. Joist spacing is relatively narrow, in the 17-18" range. In the left hand chamber, the summer tie beam has 1 3/4" to 2" flat chamfers (stops, if present, are buried in plaster).

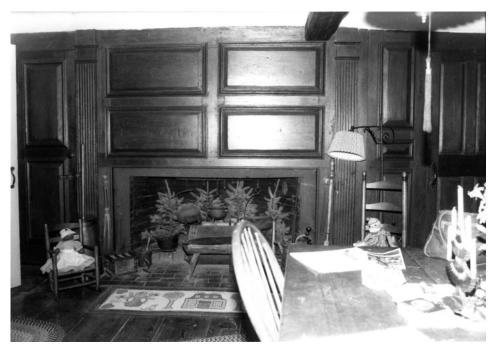
right-hand room, rear wall

In the right hand room, the only exposed original framing member is the front post supporting the transverse summer beam. The post, a simplified version of the molded post head, has a broad bevel at the lower edge of the head and inch wide flat chamfers on the upright corners. The summer beam, replaced in 1944, was given inch wide flat chamfers replicating those on the original beam. The room retains fine transitional super-raised field paneling on the rear wall, very likely relocated from an original position on the inner wall. Four panels, in which the central field projects above the surrounding bolection, and feather edges are more than two inches wide, are currently mounted horizontally over the rear fireplace. A two panel door with the same super-raised panels is at the right of the fireplace (similar paneling to the left of the fireplace was created in 1944). Pilasters of 18th century construction flank the fireplace. (See significance section for further comment on the paneling and its relocation).

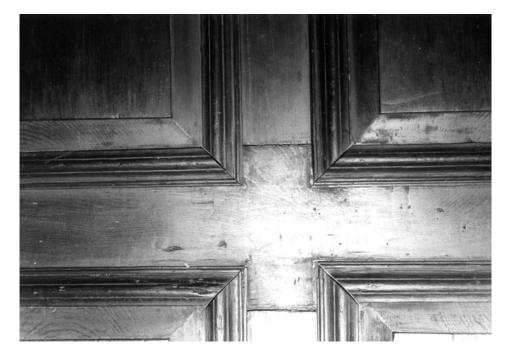
detail, paneling, rear wall, right-hand room

The staircase and the paneling in the right hand room are significant transitional elements dating to c. 1720. The paneling is particularly noteworthy. True paneling, held together by stiles and rails, it goes a step beyond the finish of the Parson Barnard House in the correct rendering of Renaissance-inspired interior panelling in New England. The extreme width of the feathered edges mark the paneling as one of the earliest examples of its type. (See doors in the White-Ellery House of 1711 and fireplace wall paneling of the Paul Revere House for comparable elements). The building also meets criterion D, for the structure is likely to yield more information about the construction and enlargement of First Period buildings if the framing of the left hand rooms and the junction of the two frames is ever available for examination.
